Atlanta Public Schools/Relocation Sites

East Lake Elementary School

School Assessment Report

November 10, 2020

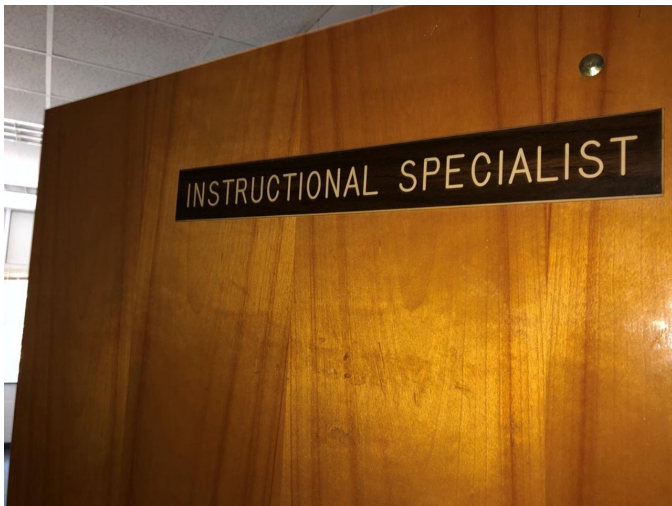
System: C1030 - Fittings

Location: Throughout Building
Distress: Beyond Expected Life
Category: ADA Compliance
Priority: 3 - Necessary (Years 2-5)
Correction: Renew System
Qty: 16,799.00
Unit of Measure: S.F.
Estimate: \$52,111.00
Assessor Name: Hayden Collins
Date Created: 09/17/2015

Notes: Fittings, such as toilet partitions, lockers, signage and railing, are beyond their expected service life, outdated and missing in areas, and should be replaced and upgraded for compliance with ADA standards.

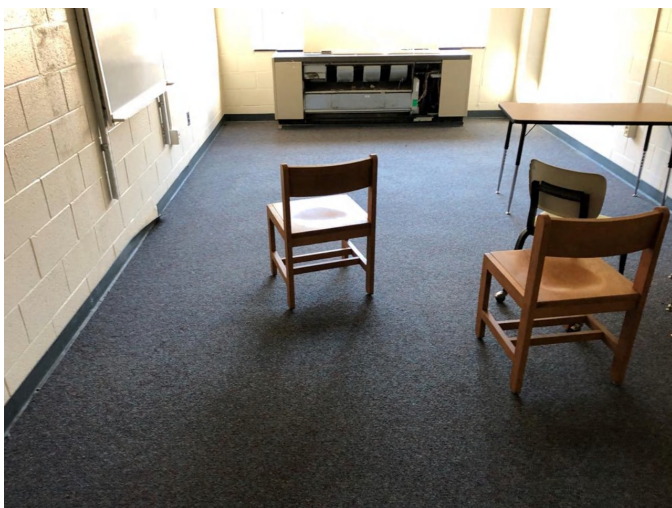
System: C3020901 - Carpet

Location: Principal's office and Main office
Distress: Beyond Expected Life
Category: Deferred Maintenance
Priority: 3 - Necessary (Years 2-5)
Correction: Renew System
Qty: 1,424.00
Unit of Measure: S.F.
Estimate: \$16,554.00
Assessor Name: Hayden Collins
Date Created: 01/20/2020

Notes: The carpet is aged, worn and stained, and should be replaced.

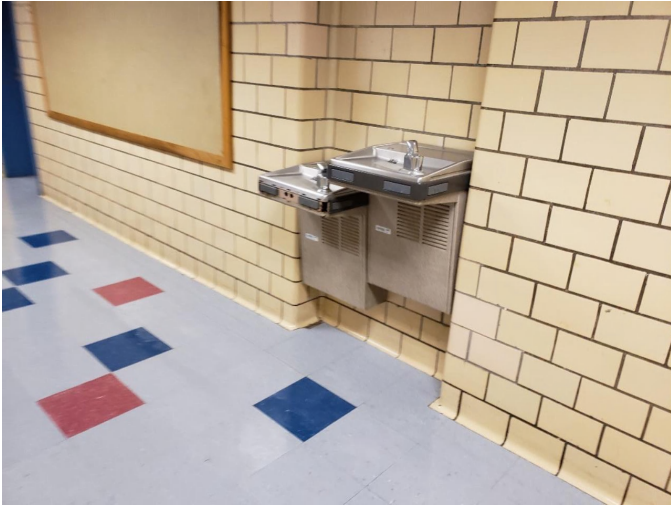
System: C3020903 - VCT

Location: Throughout building
Distress: Beyond Expected Life
Category: Deferred Maintenance
Priority: 3 - Necessary (Years 2-5)
Correction: Renew System
Qty: 14,721.00
Unit of Measure: S.F.
Estimate: \$56,352.00
Assessor Name: Hayden Collins
Date Created: 01/24/2020

Notes: The VCT floor finish is beyond its expected service life, worn and damaged, and is recommended for replacement.

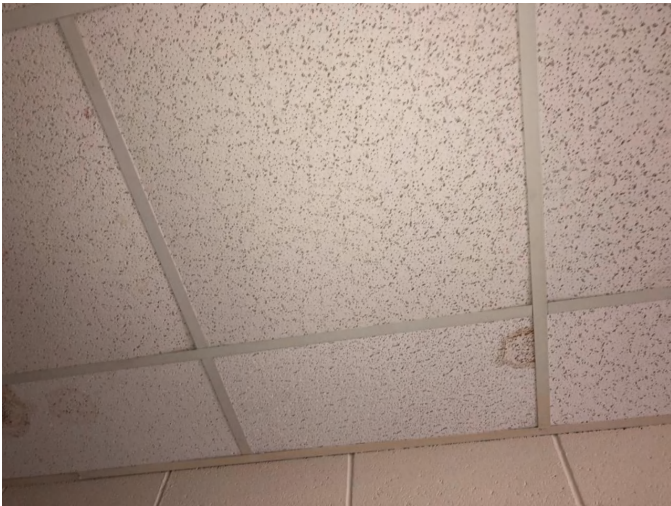
System: C3030 - Ceiling Finishes

Location: Throughout Building
Distress: Beyond Expected Life
Category: Deferred Maintenance
Priority: 3 - Necessary (Years 2-5)
Correction: Renew System
Qty: 16,799.00
Unit of Measure: S.F.
Estimate: \$177,582.00
Assessor Name: Hayden Collins
Date Created: 09/17/2015

Notes: The applied ceiling finishes have exceeded the expected life cycle and should be replaced

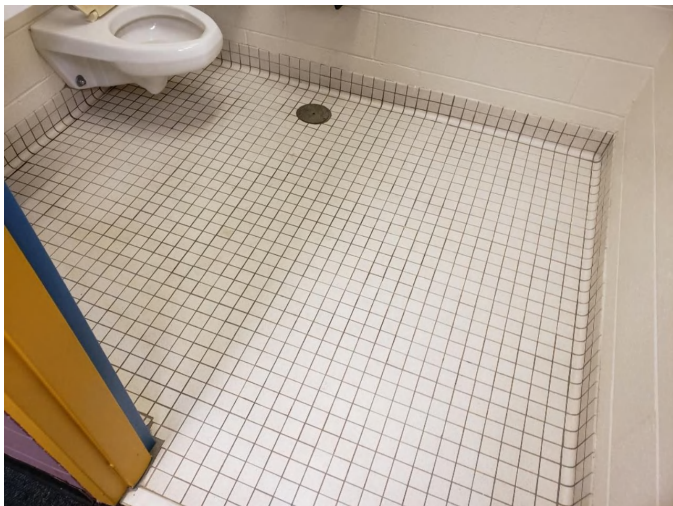
System: D2010 - Plumbing Fixtures

Location: bathrooms
Distress: Beyond Expected Life
Category: ADA Compliance
Priority: 3 - Necessary (Years 2-5)
Correction: Renew System
Qty: 16,799.00
Unit of Measure: S.F.
Estimate: \$125,287.00
Assessor Name: Jejuan Hall
Date Created: 09/17/2015

Notes: Plumbing fixtures are beyond their expected service life and should be replaced and upgraded for ADA compliance.

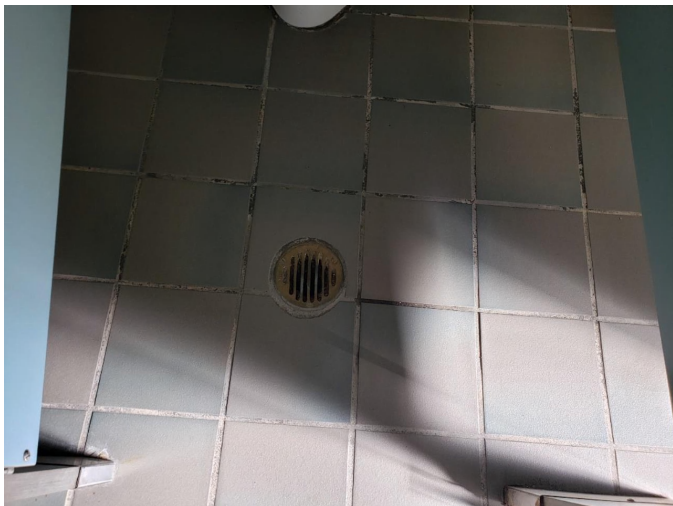
System: D2030 - Sanitary Waste

Location: bathrooms
Distress: Beyond Expected Life
Category: Deferred Maintenance
Priority: 3 - Necessary (Years 2-5)
Correction: Renew System
Qty: 16,799.00
Unit of Measure: S.F.
Estimate: \$34,001.00
Assessor Name: Hayden Collins
Date Created: 09/10/2013

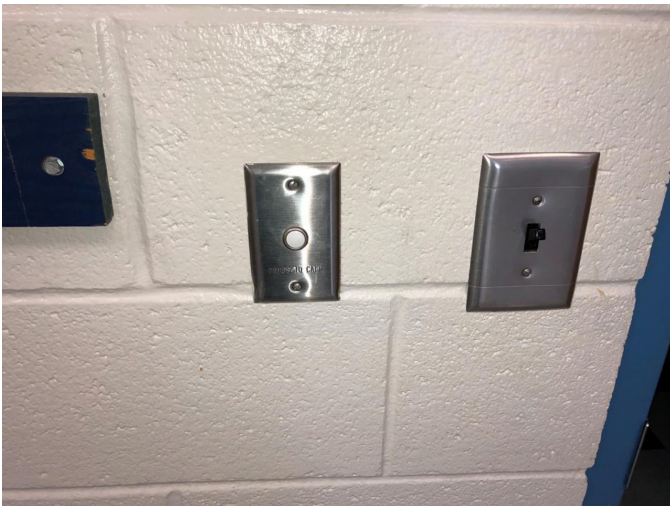
System: D5020 - Branch Wiring

Location: Throughout Building
Distress: Beyond Expected Life
Category: Deferred Maintenance
Priority: 3 - Necessary (Years 2-5)
Correction: Renew System
Qty: 16,799.00
Unit of Measure: S.F.
Estimate: \$87,775.00
Assessor Name: Hayden Collins
Date Created: 09/17/2015

Notes: The branch wiring system is beyond its expected service life and should be replaced or upgraded.

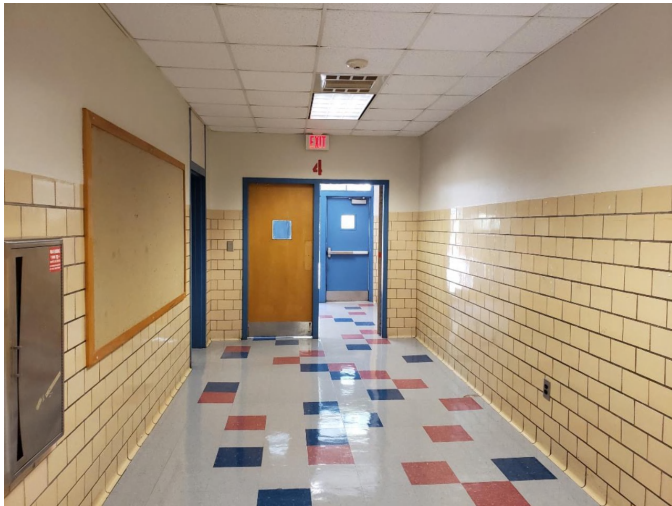
System: D5020 - Lighting

Location: Throughout Building
Distress: Beyond Expected Life
Category: Deferred Maintenance
Priority: 3 - Necessary (Years 2-5)
Correction: Renew System
Qty: 16,799.00
Unit of Measure: S.F.
Estimate: \$131,755.00
Assessor Name: Hayden Collins
Date Created: 01/17/2020

Notes: The lighting system is operational but is aged and should be replaced with an energy efficient system.

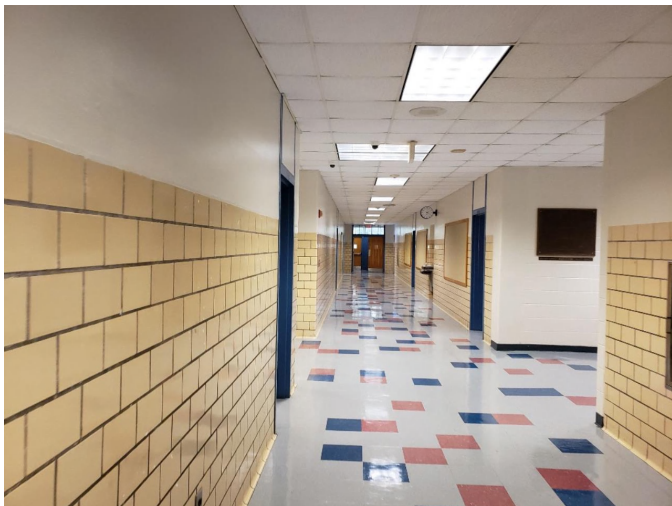
System: D5030810 - Security & Detection Systems

Location: Throughout Building
Distress: Beyond Expected Life
Category: Deferred Maintenance
Priority: 3 - Necessary (Years 2-5)
Correction: Renew System
Qty: 16,799.00
Unit of Measure: S.F.
Estimate: \$27,903.00
Assessor Name: Hayden Collins
Date Created: 01/20/2020

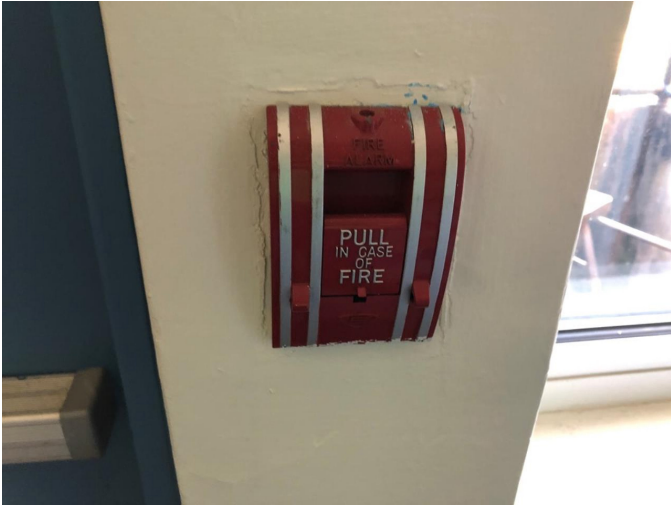
System: D5030910 - Fire Alarm Systems

Location: Throughout Building
Distress: Beyond Expected Life
Category: Deferred Maintenance
Priority: 3 - Necessary (Years 2-5)
Correction: Renew System
Qty: 16,799.00
Unit of Measure: S.F.
Estimate: \$50,632.00
Assessor Name: Hayden Collins
Date Created: 01/20/2020

Notes: This facility is protected by a central fire alarm system. The devices that serve this system include manual pull stations, audible/visible devices, and smoke detectors. The system is beyond its expected service life and should be scheduled for replacement.

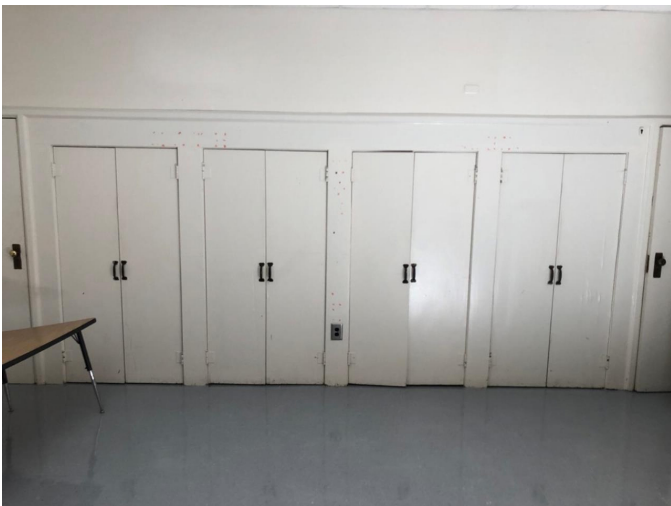
System: E2010 - Fixed Furnishings

Location: Throughout Building
Distress: Beyond Expected Life
Category: Deferred Maintenance
Priority: 3 - Necessary (Years 2-5)
Correction: Renew System
Qty: 16,799.00
Unit of Measure: S.F.
Estimate: \$38,806.00
Assessor Name: Hayden Collins
Date Created: 09/17/2015

Notes: Fixed furnishings are aged, worn and damaged, and should be scheduled for replacement.

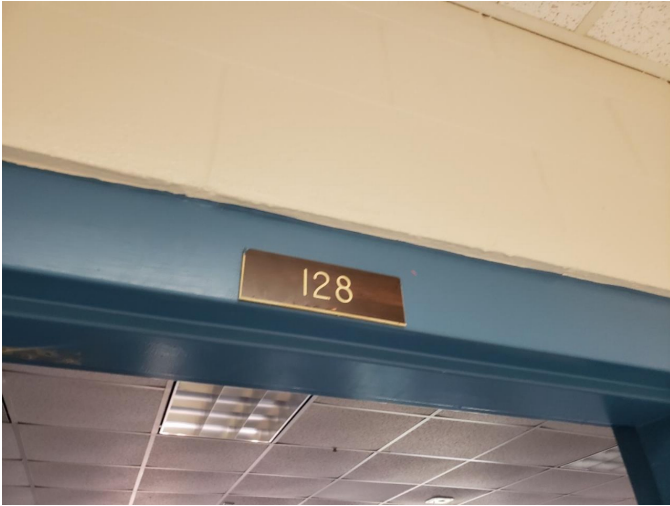
System: C1030 - Fittings

Location: Throughout Building
Distress: Beyond Expected Life
Category: ADA Compliance
Priority: 3 - Necessary (Years 2-5)
Correction: Renew System
Qty: 49,369.00
Unit of Measure: S.F.
Estimate: \$143,911.00
Assessor Name: Jejuan Hall
Date Created: 09/17/2015

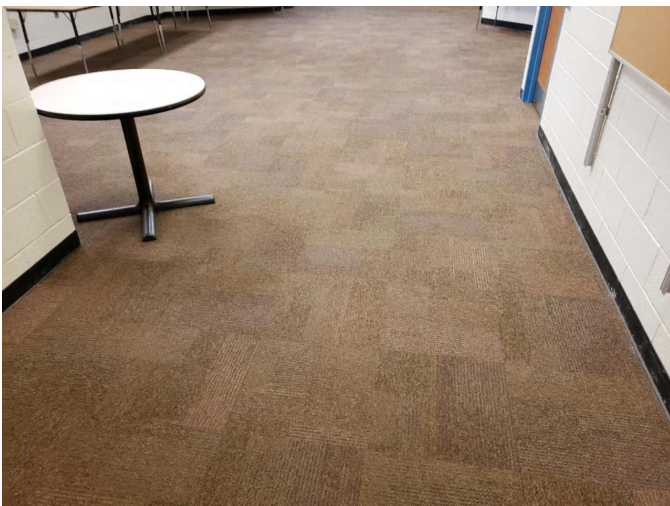
System: C3020901 - Carpet

Location: Media Center
Distress: Beyond Expected Life
Category: Deferred Maintenance
Priority: 3 - Necessary (Years 2-5)
Correction: Renew System
Qty: 5,299.00
Unit of Measure: S.F.
Estimate: \$43,717.00
Assessor Name: Homero Guerrero
Date Created: 01/20/2020

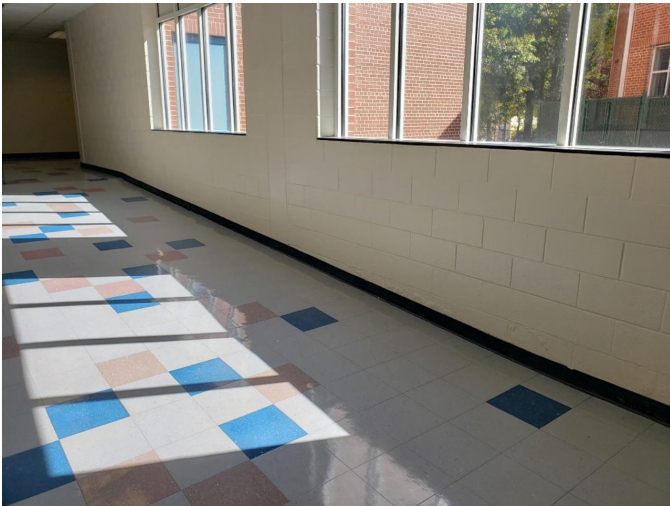
System: C3020903 - VCT

Location: Throughout building
Distress: Beyond Expected Life
Category: Deferred Maintenance
Priority: 3 - Necessary (Years 2-5)
Correction: Renew System
Qty: 40,366.00
Unit of Measure: S.F.
Estimate: \$217,734.00
Assessor Name: Homero Guerrero
Date Created: 01/24/2020

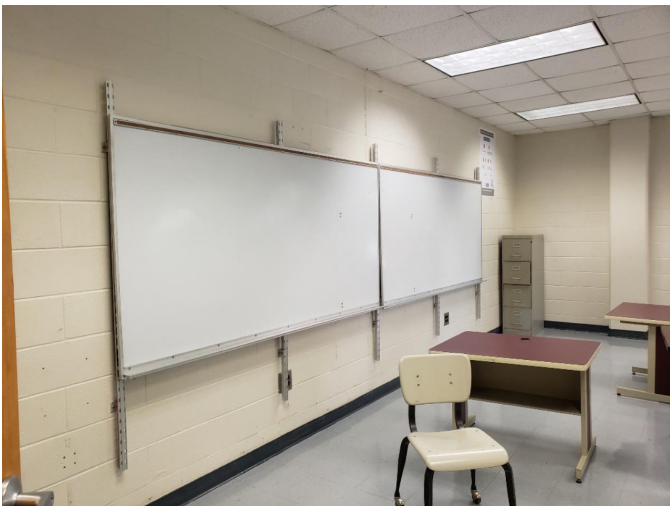
System: C3030 - Ceiling Finishes

Location: Throughout Building
Distress: Beyond Expected Life
Category: Deferred Maintenance
Priority: 3 - Necessary (Years 2-5)
Correction: Renew System
Qty: 49,369.00
Unit of Measure: S.F.
Estimate: \$492,011.00
Assessor Name: Homero Guerrero
Date Created: 09/17/2015

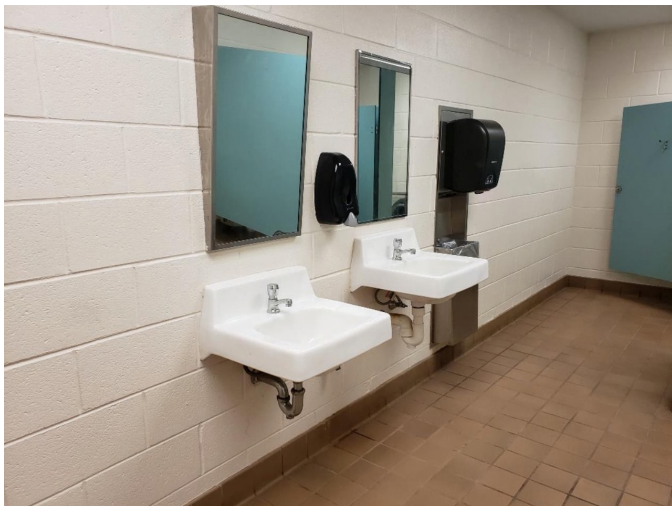
System: D2010 - Plumbing Fixtures

Location: restrooms
Distress: Beyond Expected Life
Category: ADA Compliance
Priority: 3 - Necessary (Years 2-5)
Correction: Renew System
Qty: 49,369.00
Unit of Measure: S.F.
Estimate: \$347,558.00
Assessor Name: Jejuan Hall
Date Created: 09/17/2015

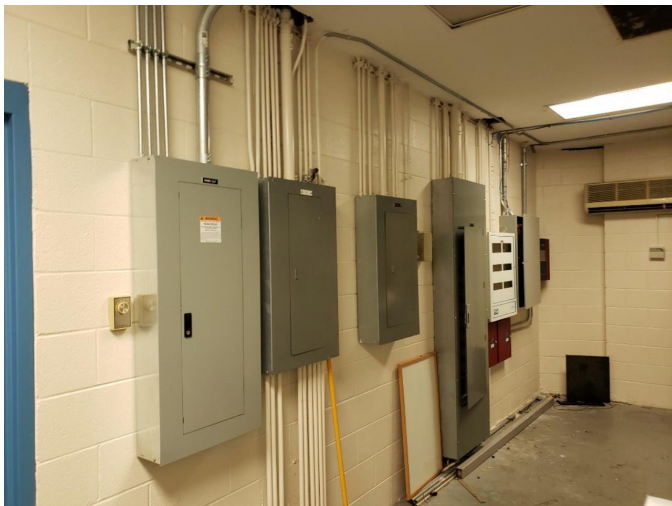
System: D5020 - Branch Wiring

Location: Throughout Building
Distress: Beyond Expected Life
Category: Deferred Maintenance
Priority: 3 - Necessary (Years 2-5)
Correction: Renew System
Qty: 49,369.00
Unit of Measure: S.F.
Estimate: \$257,953.00
Assessor Name: Homero Guerrero
Date Created: 09/17/2015

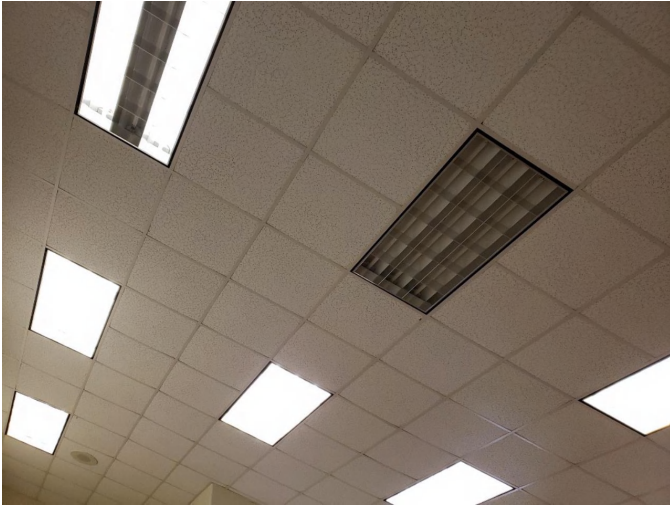
System: D5020 - Lighting

Location: Throughout Building
Distress: Beyond Expected Life
Category: Deferred Maintenance
Priority: 3 - Necessary (Years 2-5)
Correction: Renew System
Qty: 49,369.00
Unit of Measure: S.F.
Estimate: \$387,201.00
Assessor Name: Homero Guerrero
Date Created: 01/17/2020

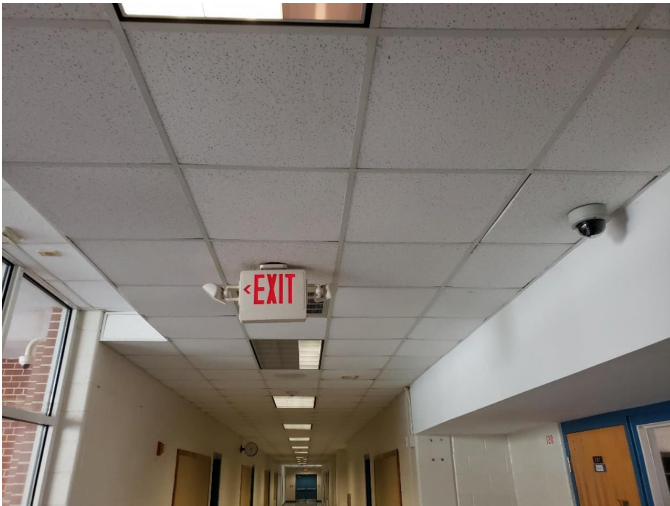
System: D5030810 - Security & Detection Systems

Location: Throughout Building
Distress: Beyond Expected Life
Category: Deferred Maintenance
Priority: 3 - Necessary (Years 2-5)
Correction: Renew System
Qty: 49,369.00
Unit of Measure: S.F.
Estimate: \$82,002.00
Assessor Name: Homero Guerrero
Date Created: 01/20/2020

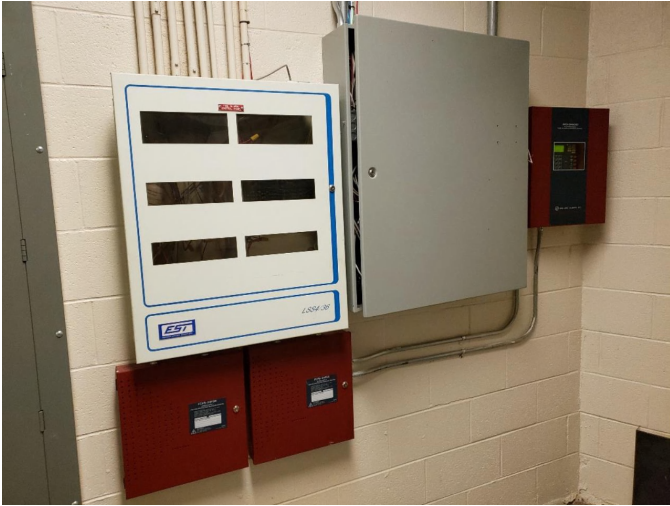
System: D5030910 - Fire Alarm Systems

Location: Throughout Building
Distress: Beyond Expected Life
Category: Deferred Maintenance
Priority: 3 - Necessary (Years 2-5)
Correction: Renew System
Qty: 49,369.00
Unit of Measure: S.F.
Estimate: \$148,798.00
Assessor Name: Homero Guerrero
Date Created: 01/20/2020

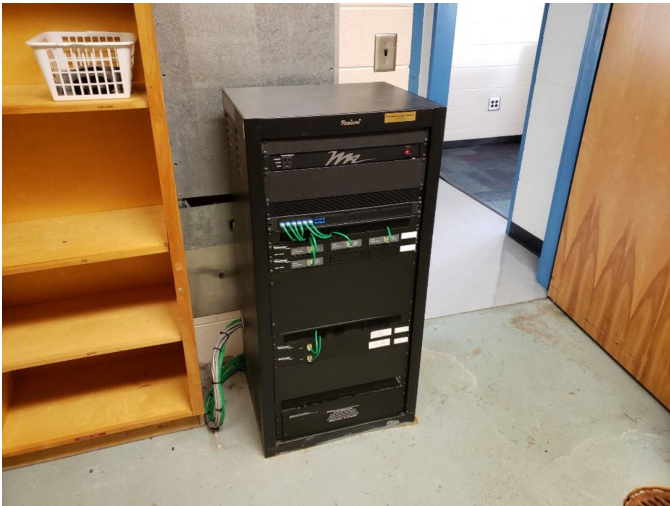
System: D5030920 - Data Communication

Location: MDF, IDF and Main Office
Distress: Beyond Expected Life
Category: Deferred Maintenance
Priority: 3 - Necessary (Years 2-5)
Correction: Renew System
Qty: 49,369.00
Unit of Measure: S.F.
Estimate: \$193,329.00
Assessor Name: Homero Guerrero
Date Created: 01/20/2020

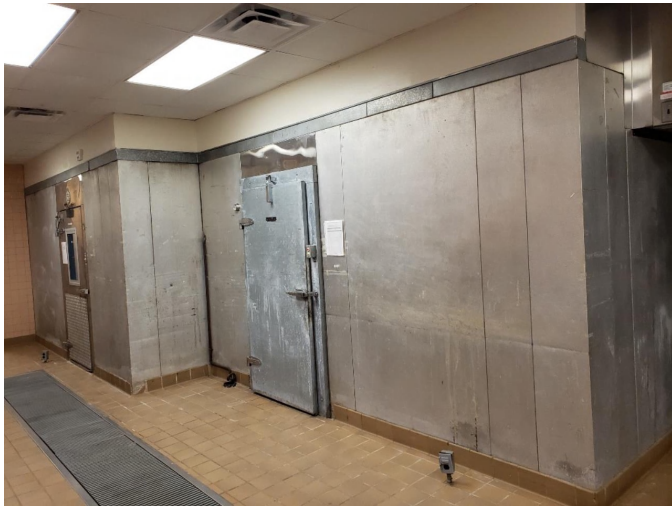
System: E1090 - Other Equipment

Location: Gym and kitchen
Distress: Beyond Expected Life
Category: Deferred Maintenance
Priority: 3 - Necessary (Years 2-5)
Correction: Renew System
Qty: 49,369.00
Unit of Measure: S.F.
Estimate: \$42,359.00
Assessor Name: Homero Guerrero
Date Created: 09/17/2015

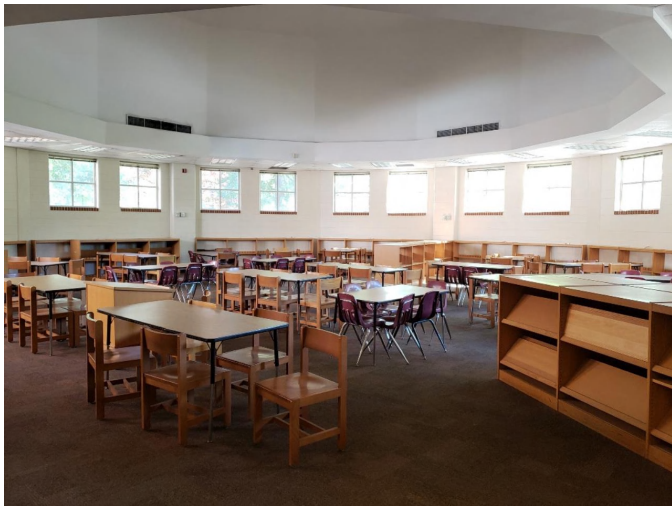
System: E2010 - Fixed Furnishings

Location: Throughout Building
Distress: Beyond Expected Life
Category: Deferred Maintenance
Priority: 3 - Necessary (Years 2-5)
Correction: Renew System
Qty: 49,369.00
Unit of Measure: S.F.
Estimate: \$105,353.00
Assessor Name: Homero Guerrero
Date Created: 09/17/2015
