Atlanta Public Schools/Relocation Sites

East Lake Elementary School

School Assessment Report

November 10, 2020

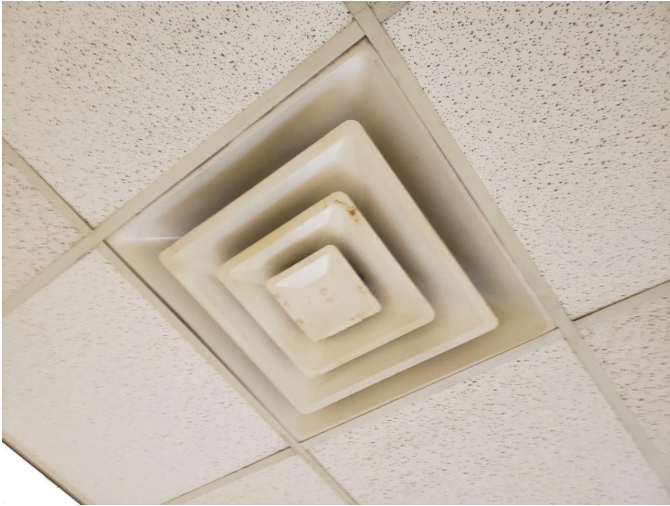
System: D3040 - Distribution Systems

Location: Throughout Building
Distress: Beyond Expected Life
Category: Deferred Maintenance
Priority: 3 - Necessary (Years 2-5)
Correction: Renew System
Qty: 16,799.00
Unit of Measure: S.F.
Estimate: \$209,736.00
Assessor Name: Hayden Collins
Date Created: 01/20/2020

Notes: The exhaust system is from original construction. This system is beyond the expected life cycle for this application. Upgrades are warranted.

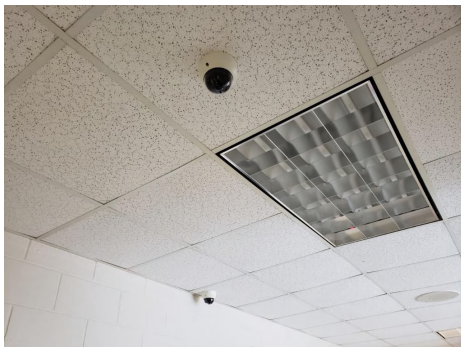
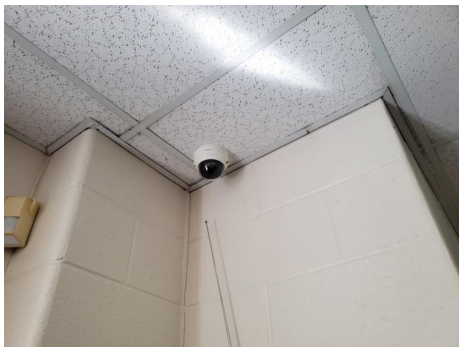
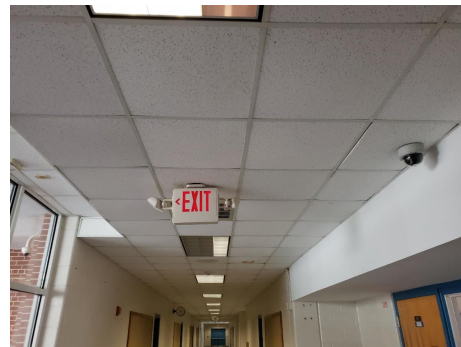
System: D5030810 - Security & Detection Systems

Notes: This facilities security and alarm system is beyond its expected service life and upgrades are recommended for the system.

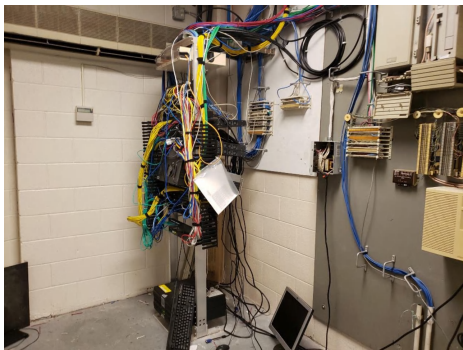
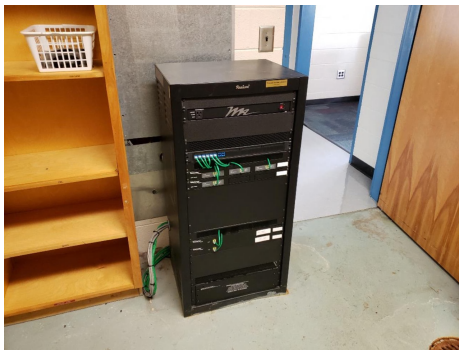
System: D5030920 - Data Communication

Notes: This facility has a data communications system that is beyond its expected service life. The installation of a new data system is recommended.

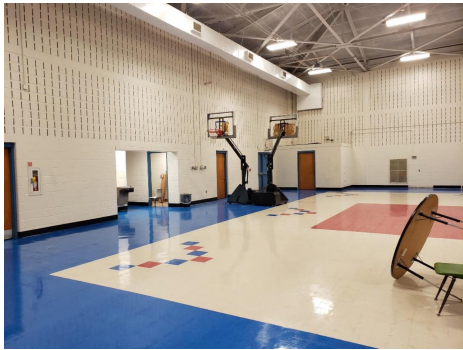
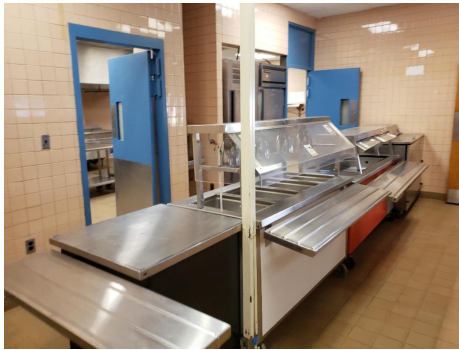
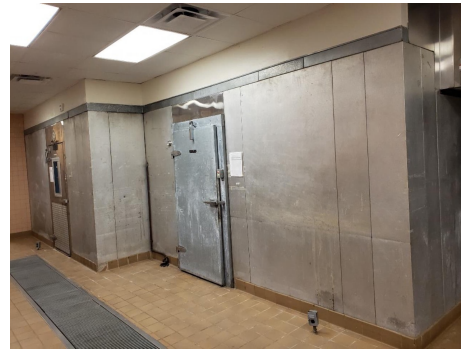
System: E1090 - Other Equipment

Notes: The kitchen equipment and gym equipment are in fair condition. However, the systems are beyond the expected service life and upgrades are warranted.

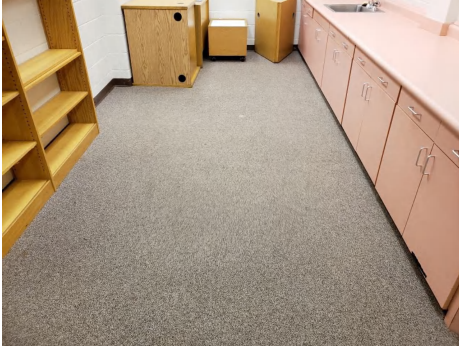
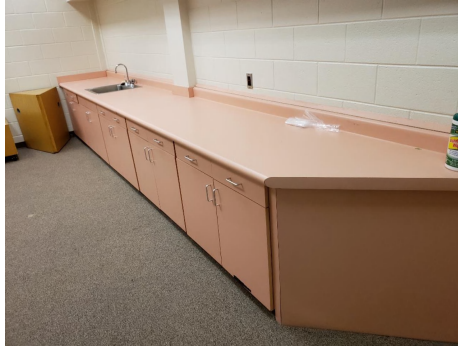
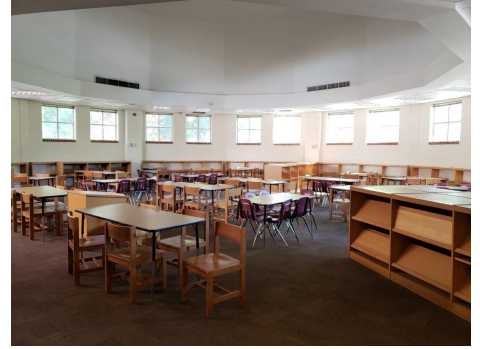
System: E2010 - Fixed Furnishings

Notes: Fixed furnishings are aged and beyond its expected life and should be scheduled for replacement.

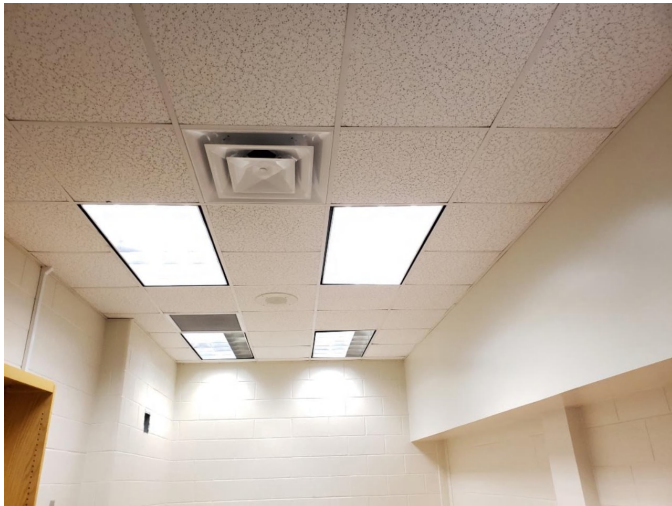
System: D3040 - Distribution Systems

Location: Throughout Building
Distress: Beyond Expected Life
Category: Deferred Maintenance
Priority: 3 - Necessary (Years 2-5)
Correction: Renew System
Qty: 49,369.00
Unit of Measure: S.F.
Estimate: \$865,093.00
Assessor Name: Homero Guerrero
Date Created: 09/17/2015

Notes: The exhaust system is beyond the expected life cycle for this application. Upgrades are warranted.

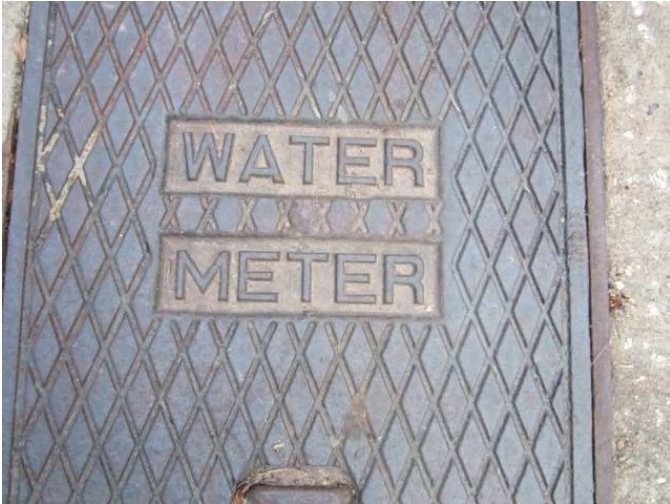
System: G3010 - Water Supply

Location: Onsite
Distress: Beyond Expected Life
Category: Deferred Maintenance
Priority: 3 - Necessary (Years 2-5)
Correction: Renew System
Qty: 66,168.00
Unit of Measure: S.F.
Estimate: \$106,994.00
Assessor Name: Hayden Collins
Date Created: 09/10/2013

Notes: The water supply system is beyond the expected life cycle. Upgrades to the system are considered necessary.

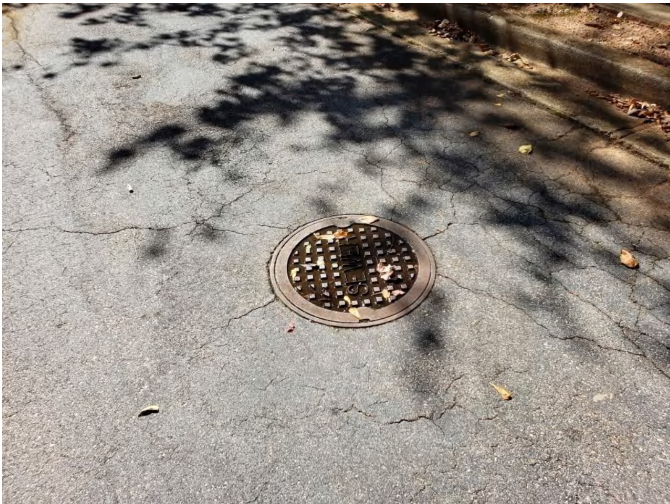
System: G3020 - Sanitary Sewer

Location: Site
Distress: Beyond Expected Life
Category: Deferred Maintenance
Priority: 3 - Necessary (Years 2-5)
Correction: Renew System
Qty: 66,168.00
Unit of Measure: S.F.
Estimate: \$219,082.00
Assessor Name: Hayden Collins
Date Created: 02/21/2020

The current sanitary system is original and nearing full capacity limiting the potential for future development and raising issues with current usage. Upgrades to the existing sanitary sewer system are considered necessary

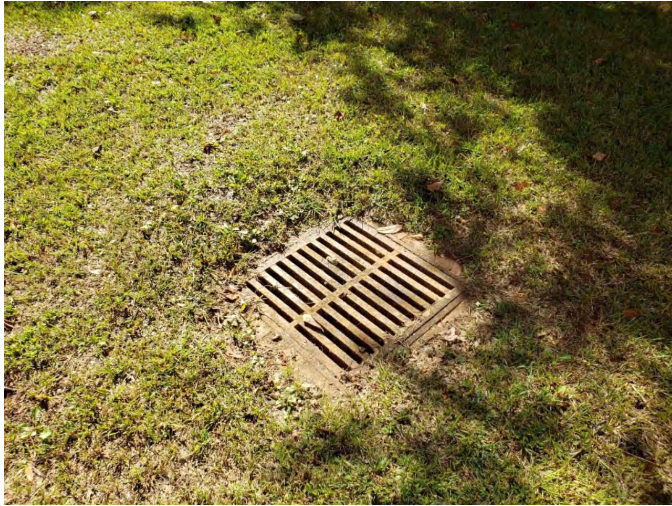
System: G3030 - Storm Sewer

Location: Site
Distress: Beyond Expected Life
Category: Deferred Maintenance
Priority: 3 - Necessary (Years 2-5)
Correction: Renew System
Qty: 66,168.00
Unit of Measure: S.F.
Estimate: \$125,190.00
Assessor Name: Hayden Collins
Date Created: 02/21/2020

Facility experiences through wall water leakage during rain events at the gymnasium and adjacent alcove of building. Water enters building low on wall where there is no storm sewer system in place.
